Structural Assessment

Job No.: SAM

Client: SAMPLE CLIENT Site Visit Date: DATE

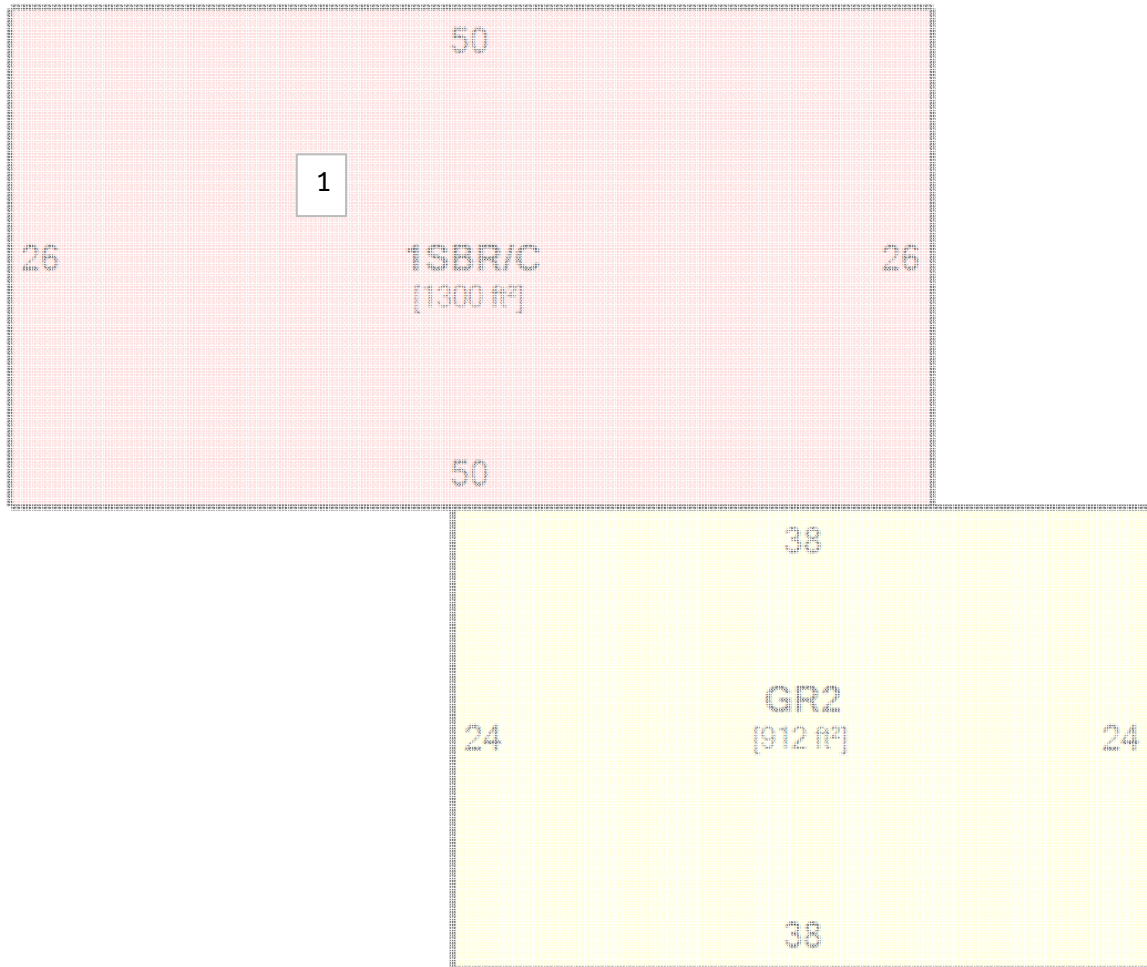
Location: Basement

1,2	Sagging hallway/living room floor and interior drywall cracking are due to a sagging crawlspace beam. Crawlspace was entered in January to confirm beam condition - was not entered in this visit.
3,4	Exterior brick façade cracking due to corrosion of steel lintel. Separation of CMU backing at the lintel elevation was observed. The section of wall above the lintel has been pulled out likely due to wind suction pressure. Wall and façade are currently stable, but the situation could change quickly.
5,8	Over-spanned lintel has led to cracking in the brick façade. Yard in this area is very wet. Plans for a french drain were noted on site. Drainage in this area is critical to mitigating potential settlement (see item 9).
6	Over-spanned lintel has led to cracking in the brick façade. Since façade height above windows is short and there are several windows in succession, the top facade courses are separating from the wood frame wall sheathing across the whole back of the house.

- 1. Beam should be shimmed over existing brick pier support. Piers did not appear to have settled.
- 4. CMU block wall should be replumbed and reinforced with #4 bar @ 24" in grouted cells. Existing lintel should be removed. Brick façade above window can be removed and replaced with siding panels. If brick façade is restored, a new steel angle lintel will need to be sized and installed.

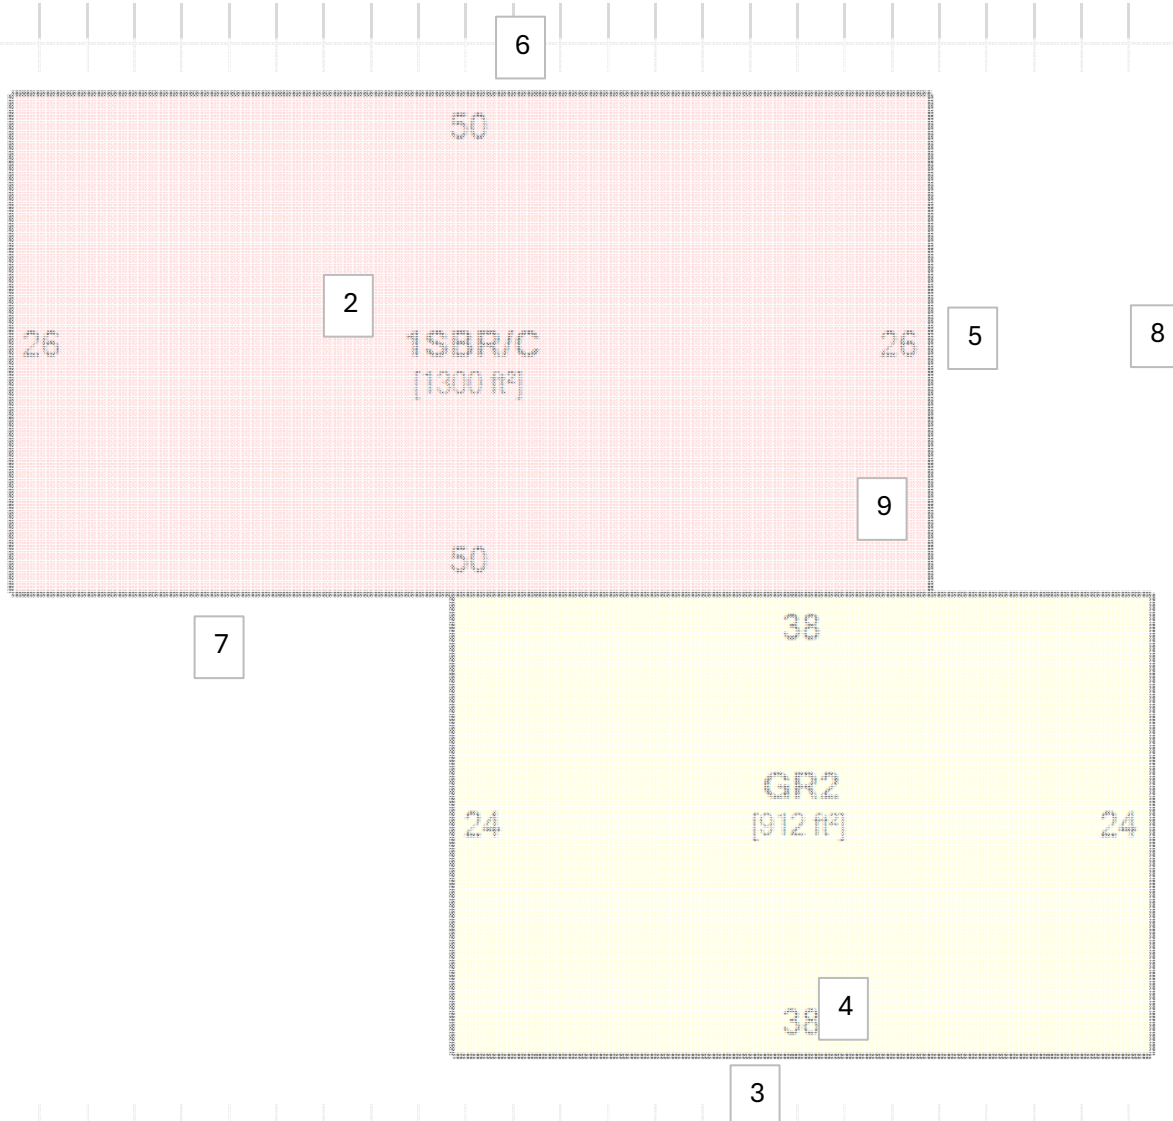
Location: First Floor

7	Over-spanned lintel has led to cracking in the brick façade.
9	Exterior wall observed to be leaning out at the top. Potential settlement cracking also observed in the closet and around the window. Standing water noted in the yard (item 8). This area may have experienced moderate settlement in the past.

<input checked="" type="checkbox"/>	Patch cracks and observe 6-12 months for return	2,4,9 _____
<input checked="" type="checkbox"/>	Reinforce CMU Wall	4 _____
